RESEARCH ON ELECTRICAL WIRING USED IN THE CONSTRUCTION OF WORKING MACHINES AND VEHICLES IN THE ASPECT OF FIRE PROTECTION

Keywords: construction of working machines, electrical wiring, fire protection

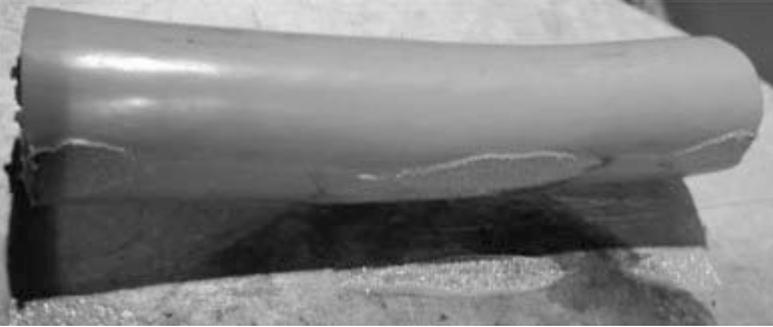
Table 5. Photos of degradation level of non-metallic components of wires due to thermal convection of the LiYCY 06 / 1kV signal cable

Temperature [°C] and time [min]	The appearance of the sample after the process
100 and 30

150 and 30

200 and 3

225 and 3

The temperature of the plate [°C]	Time of impact [min]	Surface anomaly
100	30	no changes
150	30	slight melting of PVC tire
200	3	slight melting of PVC tire
	15	beginning of pyrolysis of the PVC tire coating, which results in intensification of its melting and creation of gaseous decomposition products
	30	pyrolysis without increased intensification than in earlier 15 min
225	3	starting to melt the PVC tire coating
	4	start pyrolysis
	15	separation of coatings and wires as a result of progressive pyrolysis

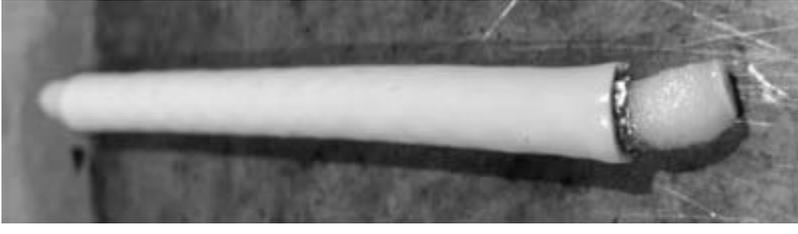
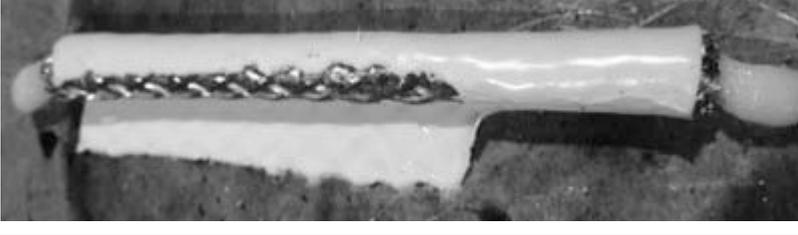
Table 6. Photos of the degree of degradation of non-metallic components of conductors as a result of convection of a steel plate with a coaxial conductor in PE foam insulation in a screen of a tape and a braid, in a polyvinyl-acetate coating

Temperature [°C] and time [min]	The appearance of the sample after the process
100 and 30

125 and 10

175 and 5

200 and 1

The temperature of the plate [°C]	Time of impact [min]	Surface anomaly
100	30	no changes
125	30	slight melting of the PVC coating
150	1	no changes
	3	no changes
	5	spillage of polyethylene foam PE insulation and plastic deformation of PVC coating
	10	spillage of polyethylene foam PE insulation and plastic deformation of PVC coating (at the same level as after 5 min)
	30	spillage of polyethylene foam PE insulation and plastic deformation of PVC coating (at the same level as 5 and 10min)
175	1	no changes
	3	spillage of polyethylene foam PE insulation and plastic deformation of PVC coating
	5	increased intensity of spillage of polyethylene foam insulation and plastic deformation of PVC coating
	7	thermal degradation of the PVC coating, delamination of the composite structure, separation of coatings
200	1	intensive spillage of polyethylene foam insulation, thermal distribution of polyvinyl PVC coating, stratification of composite structure, separation of coatings
